# SAFETY ALERT

## *Near Miss* **Paper Machine Primary Arm Clamp Failure**

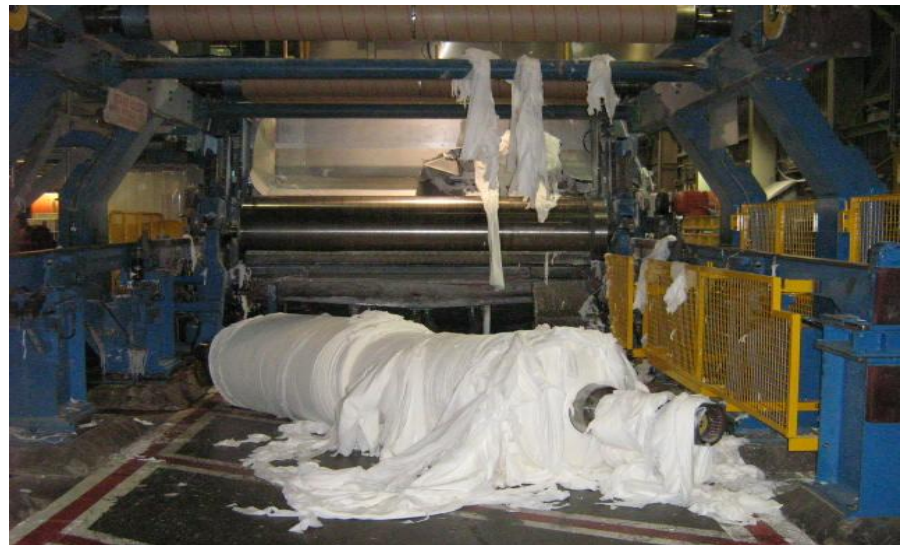
On the 10<sup>th</sup> of February a partially built reel of paper fell from a paper machine to the floor while the machine was producing paper. The reel weighed approximately one (1) tonne and could have caused significant harm to people and equipment had the circumstances been different.

- Front portion of the Voith tail threader was bent.
- UTM guard bent.
- Spindle was taken out of commission until confirmation of no damage sustained.

***Ejected reel on floor between the rails***
