13 July 2007  
Issue Number 0607

## Pasaban Coiler Accident

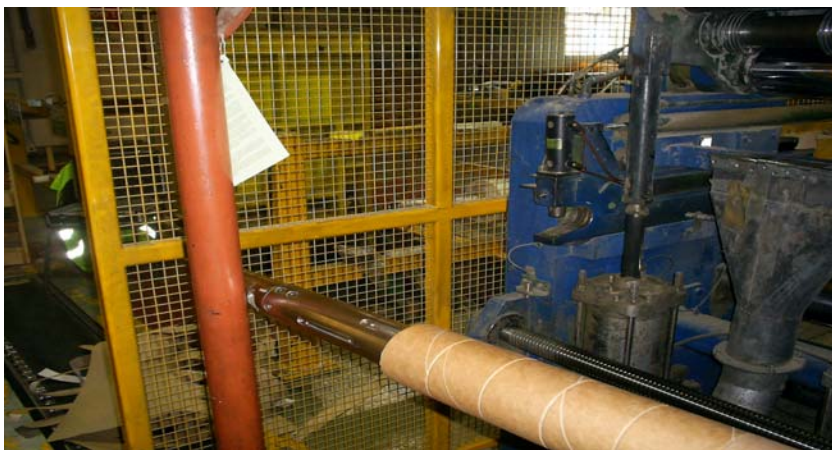
It has been reported that an incident has occurred on 19<sup>th</sup> June 2007 where an operator became caught between, the hydraulically operated retaining arm, and the web discharge end of the air shaft which supports the cores on a Pasaban coiler. The incident resulted in a crush thigh injury.

In order for the product to be ejected from the air shaft, the retaining arm retracts horizontally from the air shaft. When the start-up sequence commences the retaining arm extends, re-engaging the air bar. It was during this start-up sequence that the operator was injured.

The IP was operating a Pasaban Coiler. He activated the automatic sequence that shuts a back side guard and extends the support arm for the air bar. For some reason (to be investigated) it is understood that the IP entered the area and was caught between the support arm & the air bar.

The mill with approval from the local HM Inspector, changed a switch to a "hold to run" to eliminate the entrapment risk and made the task single operator only.

As a result the Mill is reviewing operating procedures on this and all other similar machines.
