Incident Investigation Summary Report

Description of the accident:

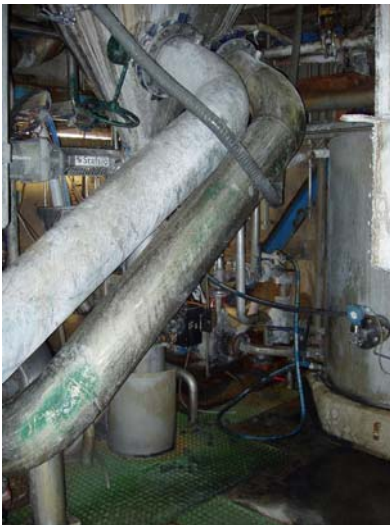
Place of accident

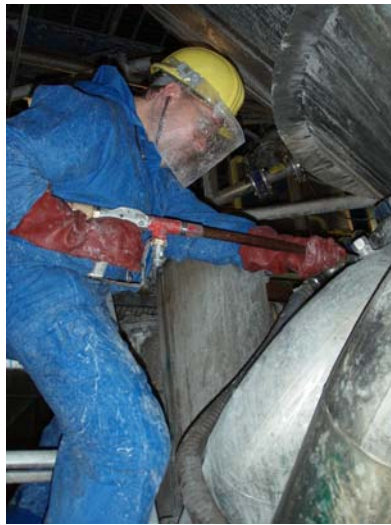
Employee working with the high-pressure pistol

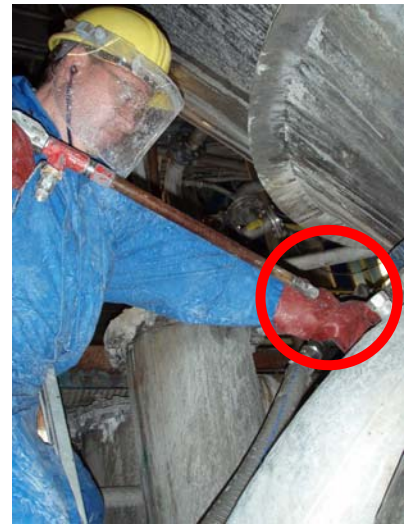
The worker held the high-pressure pistol at the trigger guard with his right hand and stabilised the nozzle pipe with his left hand. The reaction of the water jet, accidentally directed at an obstacle, pushed the high-pressure pistol and his right hand backwards and the nozzle pipe off his left hand.

The water jet hit and penetrated the left forearm of the worker approximately 80 mm above the palmar carpal region.

Position when injured

1. Missing or wrong assessment of risk and danger in the use of high-pressure cleaning equipment and auxiliaries.
2. Use of unsuitable tool
 - Short nozzle pipe
 - No hand grip on nozzle pipe used
3. Work of such kind on ladders is accident prone on account of the rather insecure and unstable working position
4. Wet and slippery nozzle pipe, as well as wet gloves do not permit a sufficiently firm grip.

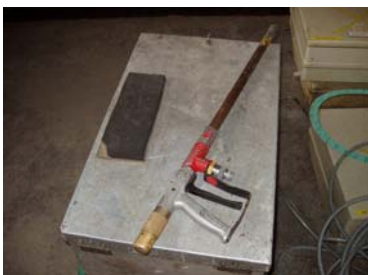
A high-pressure pistol with a 450-mm nozzle pipe was used for cleaning. The overall-length from the trigger guard of the pistol to the end of the nozzle pipe was 700 mm.

High-pressure pistol

- If not explicitly revoked, no high-pressure cleaning pistols with nozzle pipes shorter than 1000 mm may be used.
- The use of high-pressure cleaning equipment on ladders is forbidden. It must be ensured that a safe and secure working position (permanent stand, scaffolding, lifting platform, etc.) is maintained throughout the cleaning work. There will be no cleaning work done and supervisors will have to be asked for appropriate measures if these requirements cannot be met.

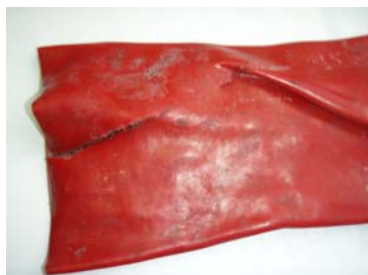
Slit glove

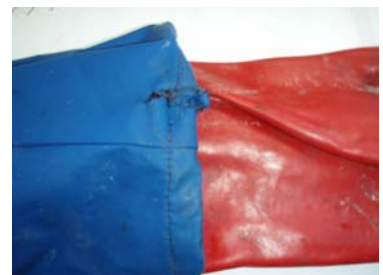
Glove and Overall

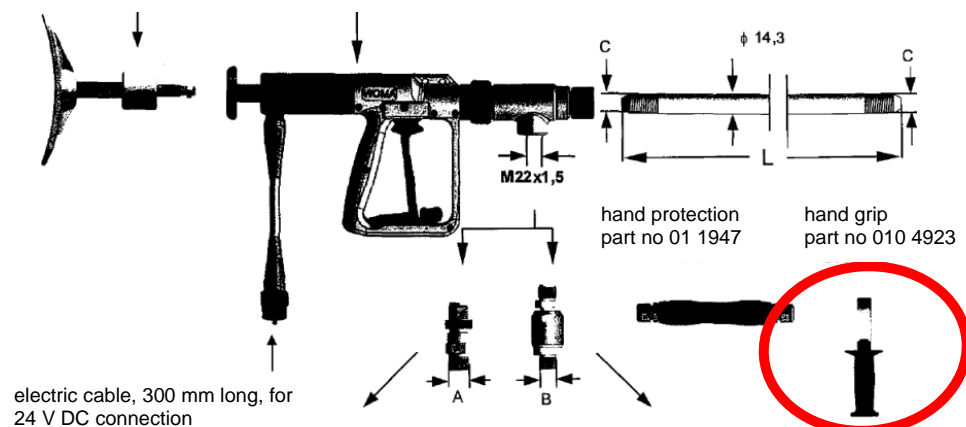
High-pressure pistol with second hand grip

No.	Description	Responsible Person	Due Date	Completion Date
1	Two new high-pressure pistols will be bought featuring a gradual pressure build-up when the trigger is actuated.			
2	All XX equipment will in future be used only with jet pipes having a second hand grip (see illustration).			
3	The personal safety equipment will in future be complemented with overshoes and with an appropriate high-pressure-jet-resisting hand protection (see pictures).

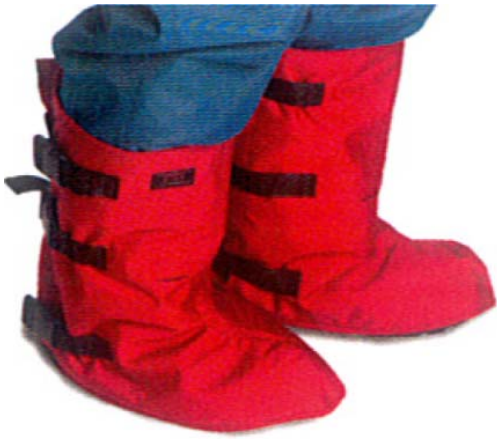
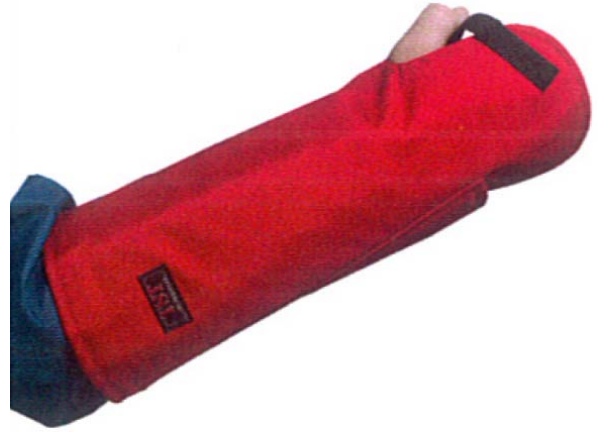
Personal safety equipment for hand and legs (up to 500 bar)
