SAFETY ALERT

Operator Injured by Rider Roll

On the 20th of June a Finishing Operator had his lower legs pinned between a Rider Roll and the Winder drums, causing soft tissue crush injuries.

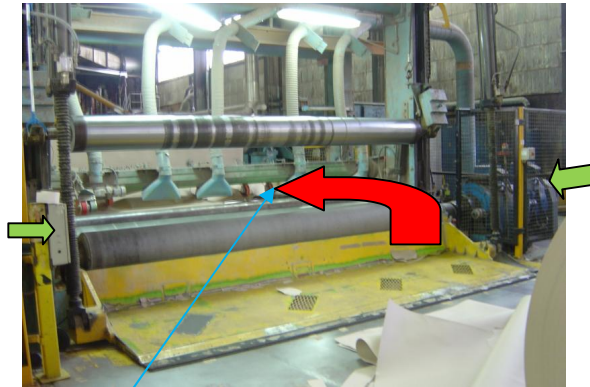
Paper Machine Winder
(Slitter area located behind Rider Roll and Winder Drum)

Path of movement of employee indicated by red arrow

Light curtain beam poles indicated by green arrows

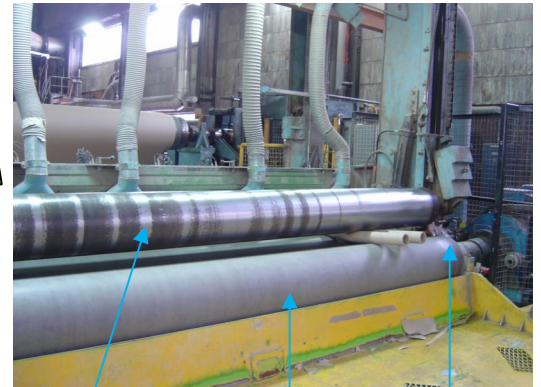
Rider Roll. Winder Drum. Cardboard Cores.
(cores indicate position of employee legs at time of incident)

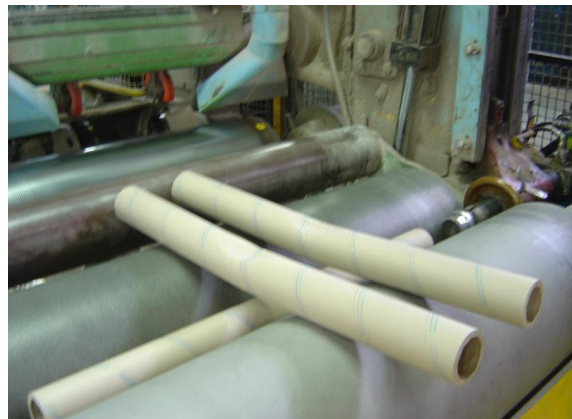
Impact of pressure on core from 'Rider' Roll

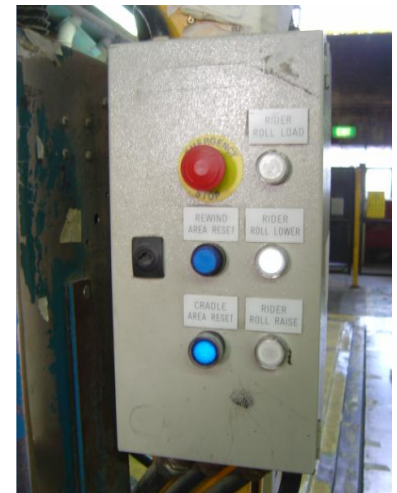
Table and Rider Roll Operating Panel

It should be noted that the Rider Roll controls had previously been moved from the shack to a control box located adjacent to the Winder to enable the Operator straight line of sight to ensure no one else is in the vicinity prior to initiating the lowering of the Rider Roll.
